Jefferson County Nearshore Restoration Feasibility Report

Prepared for:
Jefferson County Marine Resources Committee

Prepared by:
Coastal Geologic Services Inc.
Jim Johannessen, LEG, MS and
Jonathan Waggoner, BS

June 29, 2007

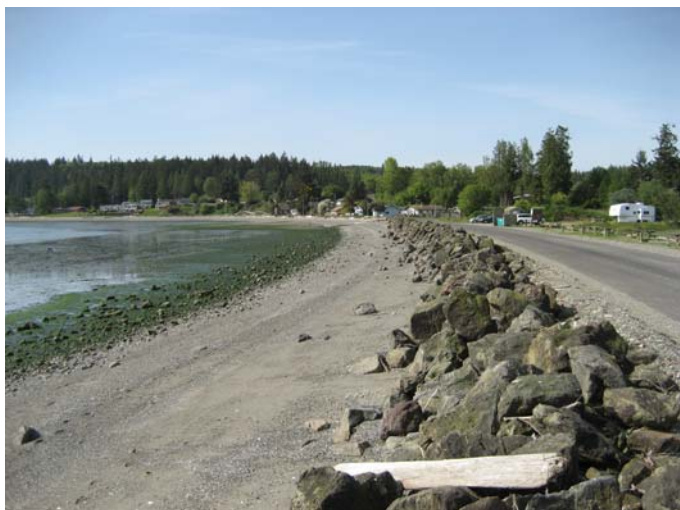
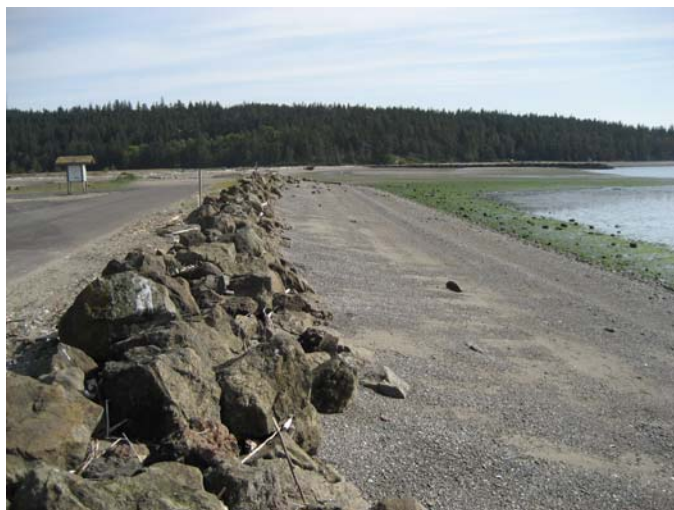
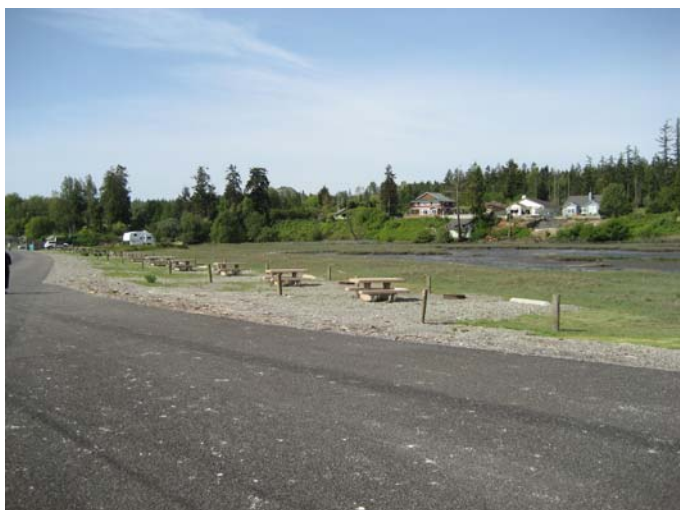
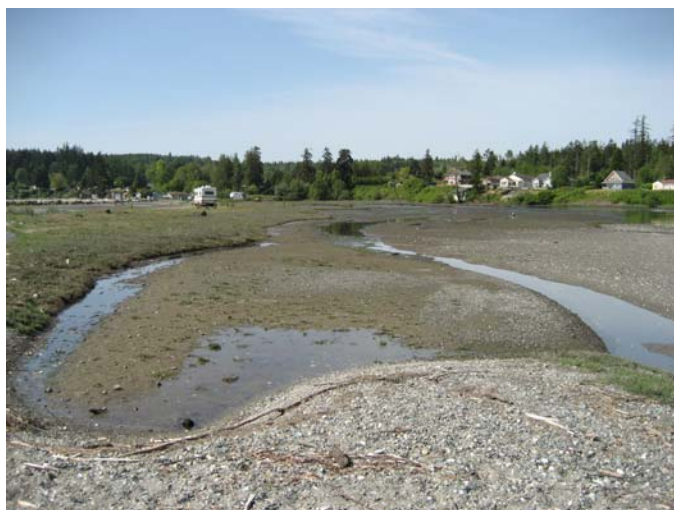
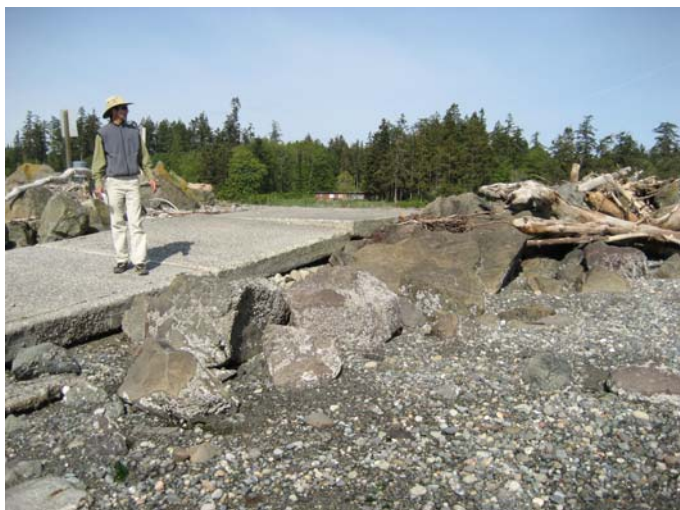
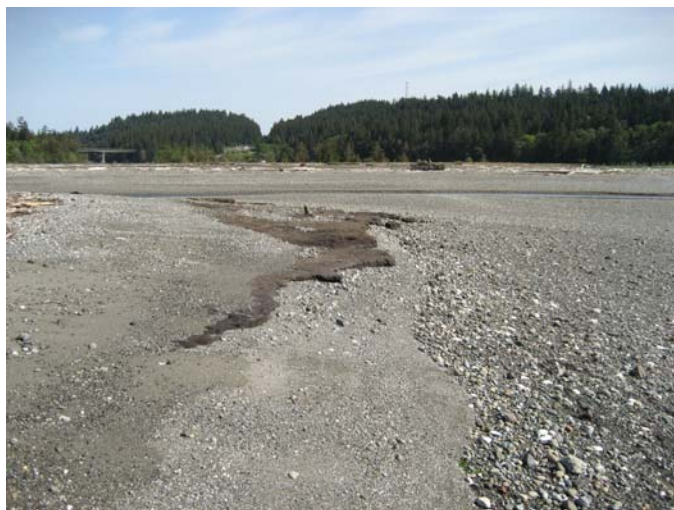
Figure 10. Oak Bay West ground photos taken May 18, 2007.

The park road and portions of the camping sites were constructed atop intertidal habitat (Figure 9). During the site visit the upper intertidal sediments appeared to be of the type utilized as spawning substrate for forage fish such as sand lance and surf smelt, which typically spawn in the upper intertidal areas (Pentilla 1978). Sand lance spawning was mapped at this site by WDFW. Since the upper intertidal was covered by rock from the rock revetment waterward of the road, this beach likely no longer provides valuable habitat services.

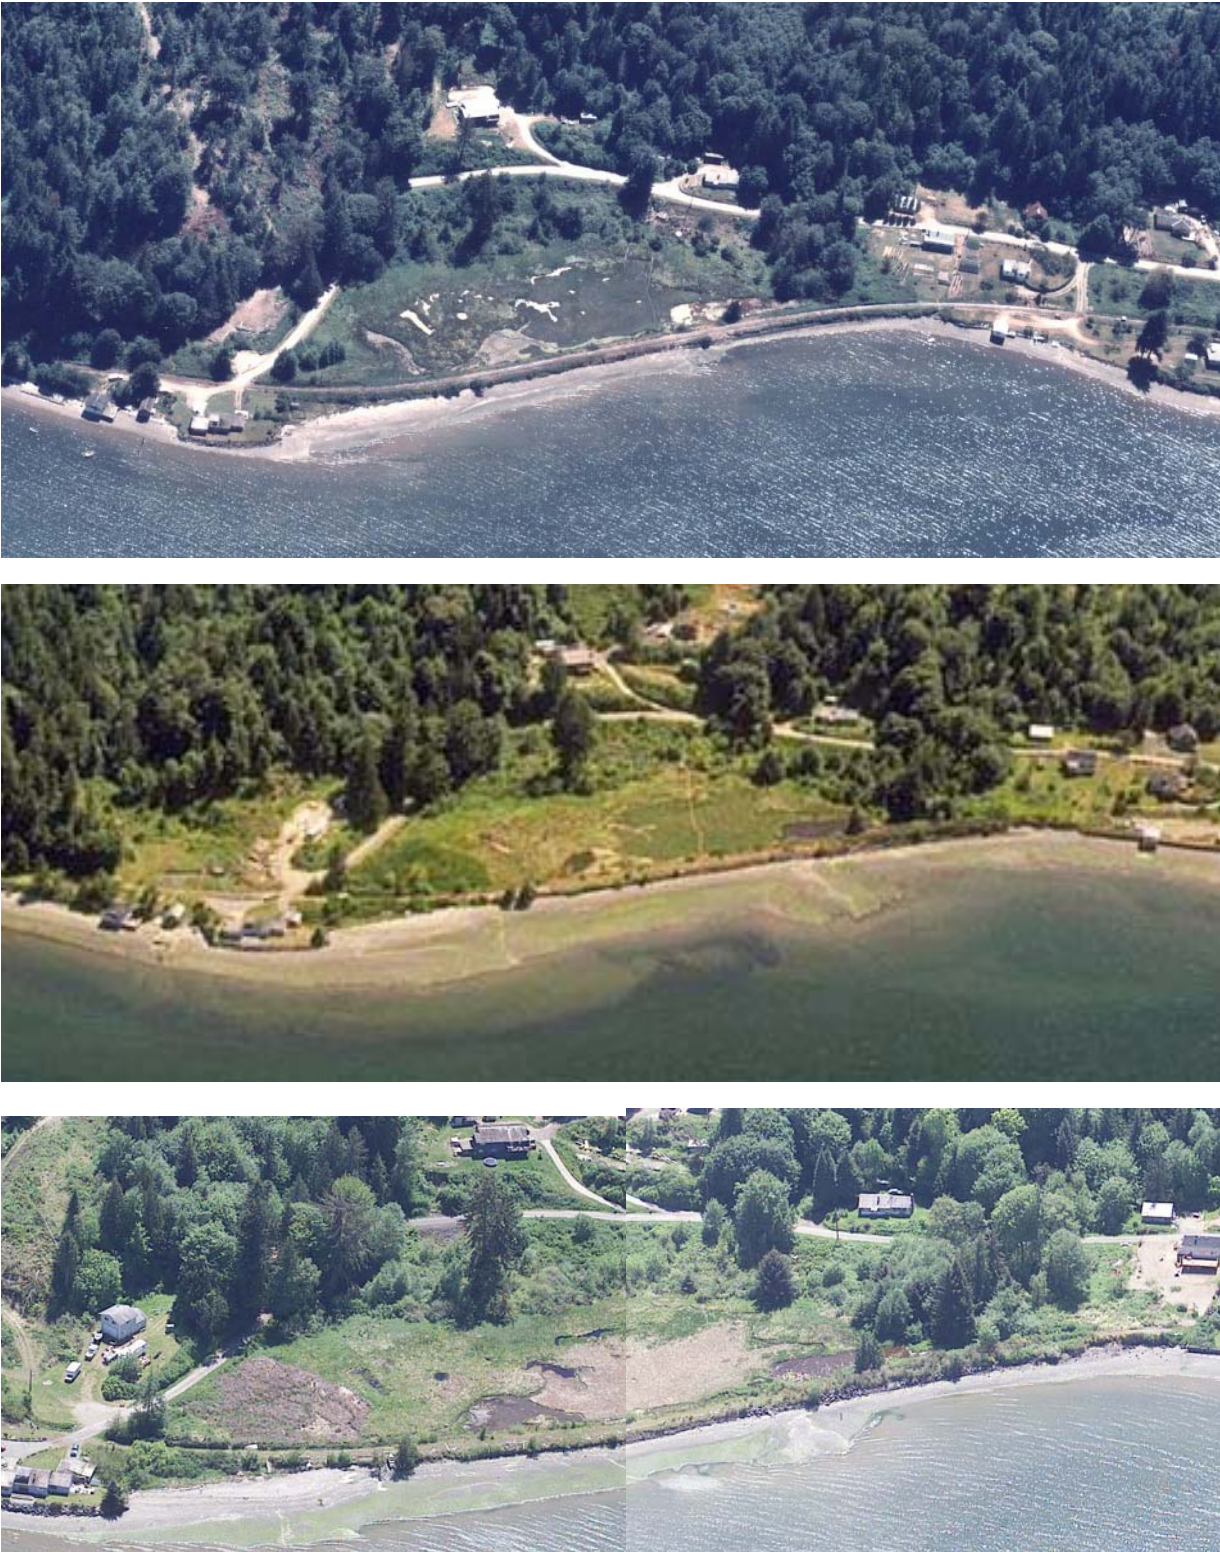
Figure 13. Tarboo Bay existing conditions

Mapping – Shoreline features at the site were mapped using DGPS. These features were all digitized and imported in a GIS for analysis (Figure 13). The line of rock was mapped as extending 350 ft alongshore, covering approximately 1,050 ft² of intertidal habitat. More habitat was covered by the smaller rip rap landward of the line of rock, but was not measured during the site visit. The remaining logs were in the central and northern portion of the site and cov a substantial amount of beach area.

A typical cross section was drawn from measurements made on site (Figure 13). Above and below the area of rock and logs the beach slope was found to be approximately 10:1 (H:V). Where the rock and logs were located the slope was approximately 6:1 (H:V).
